Manhole Inspection Summary

Manhole # S53G__005MH

Insp Date: **4/15/08 9:27 AM**

Location Address: **3311 E pratt st**

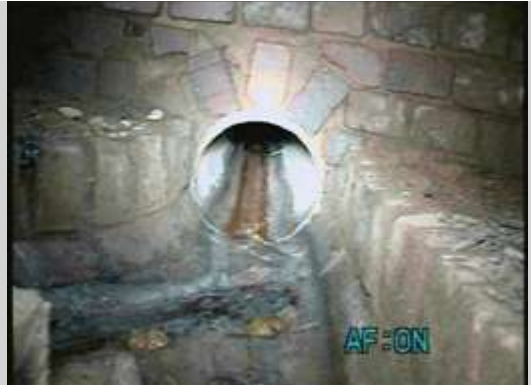
12 O'Clock Outflow

8 in. Circular Gravity Sewer
Pipe Out @ 12 O'Clock

Pipe Height: **0** (in.) Direct
Pipe Material: **Clay** ☐ Pipe Lined
Invert Depth: **7.83** (ft.) Flow Characteristics: **Fast**
Deposits: ☒ None ☐ Mud ☐ Sludge ☐ Debris ☐ Grease
Silt Depth: **0** (in.) Deposits Extent:
Infiltration: **None** Pipe Seal Cond: **Unknown**

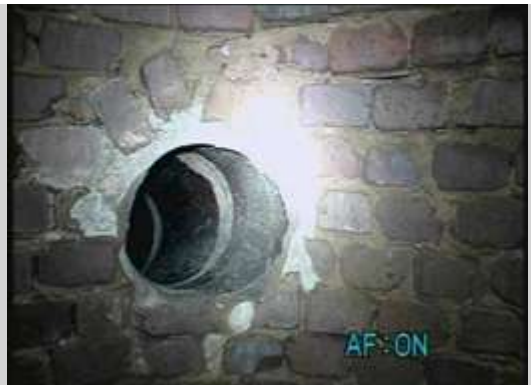
6 O'Clock Inflow

8 in. Circular Gravity Sewer
Pipe In @ 6 O'Clock

Pipe Height: **0** (in.) Direct
Pipe Material: **Clay** ☐ Pipe Lined
Invert Depth: **7.70** (ft.) Flow Characteristics: **Fast**
Deposits: ☒ None ☐ Mud ☐ Sludge ☐ Debris ☐ Grease
Silt Depth: **0** (in.) Deposits Extent:
Infiltration: **None** Pipe Seal Cond: **Unknown**

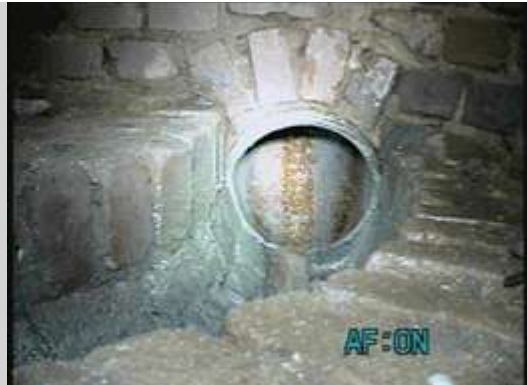
8 O'Clock Inflow

8 in. Circular Gravity Sewer

Pipe In @ 8 O'Clock

Pipe Height: 0 (in.) Direct

Pipe Material: **Clay** ☐ Pipe Lined

Infiltration: **None**
